# Signs of Retaining Wall Failure

Presented to: HOA Connect

Presented by: **Michael Anderson**

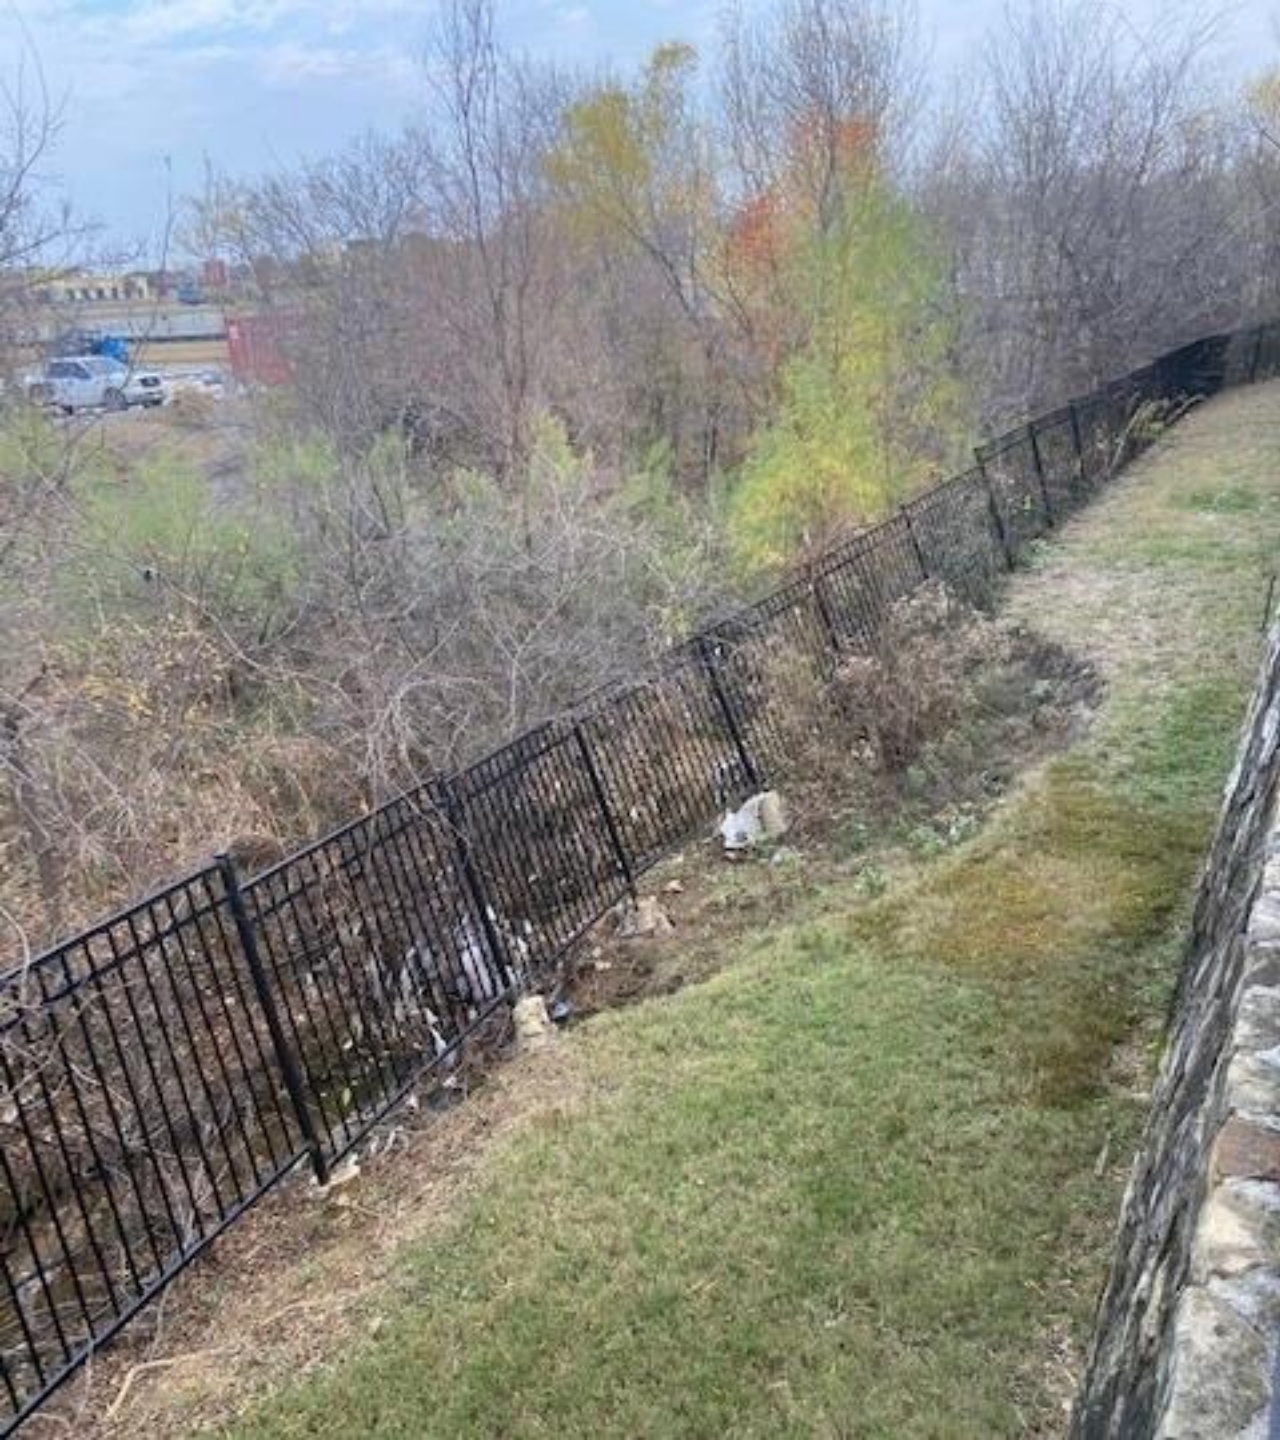
Not all retaining wall issues look like a problem with the wall. Look for bank failures below the wall as well.

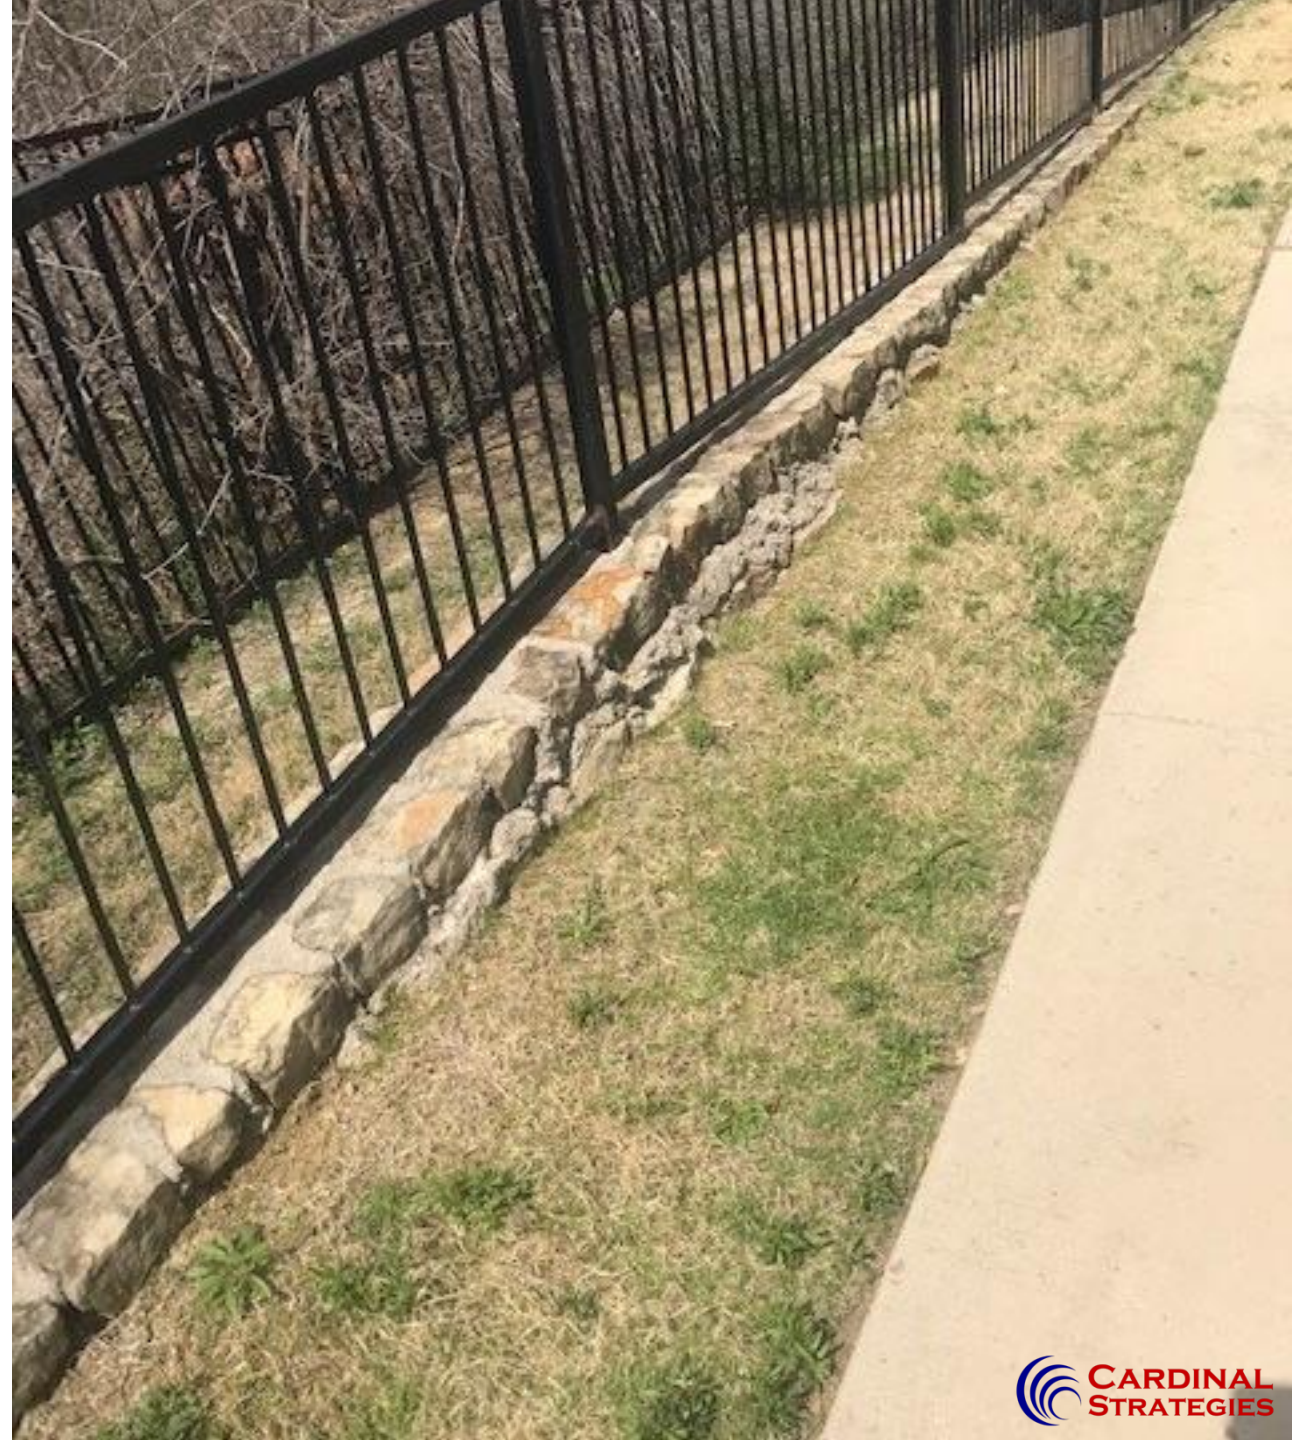
# Signs at the Top of the Wall

- Exposed rubble behind wall
- Vegetation on top indicates no surface erosion
- Lack of slope means collecting water goes behind wall

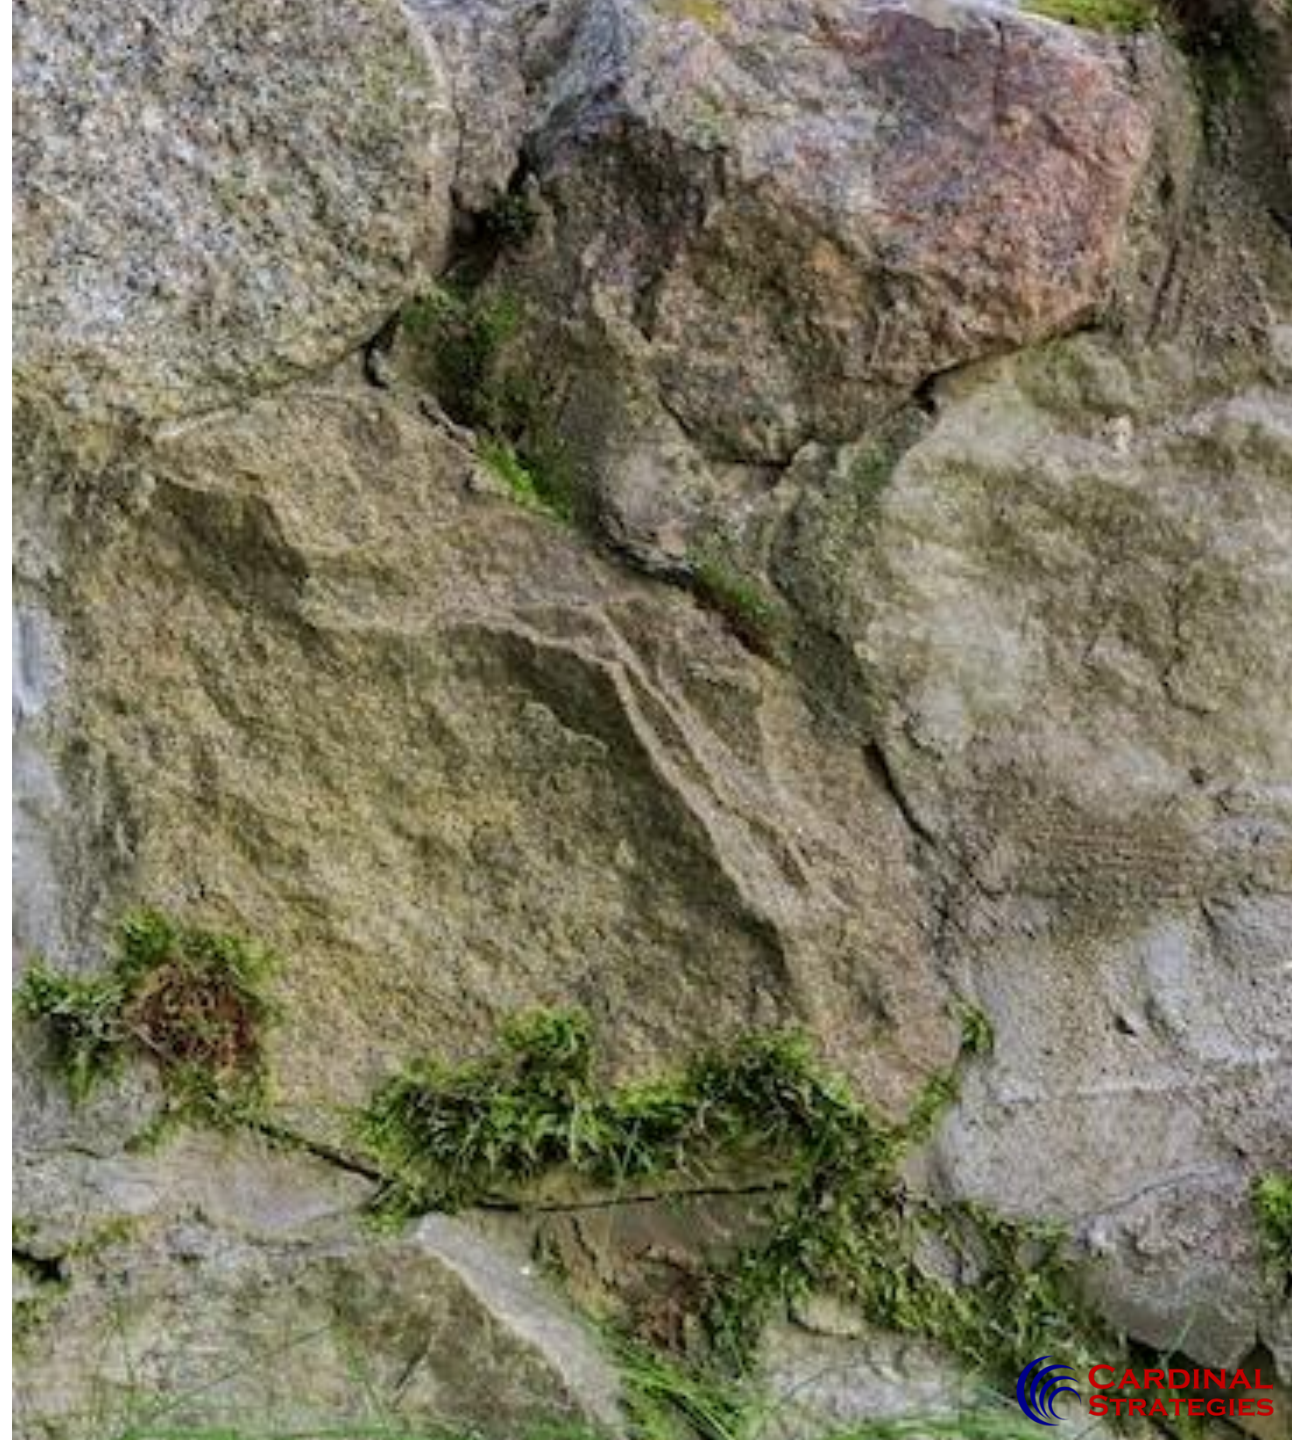
# Signs at the Wall Face

- Presence of Efflorescence or Moss/Vegetation
- Visibly bulging or leaning wall
- Cracks and separation along wall

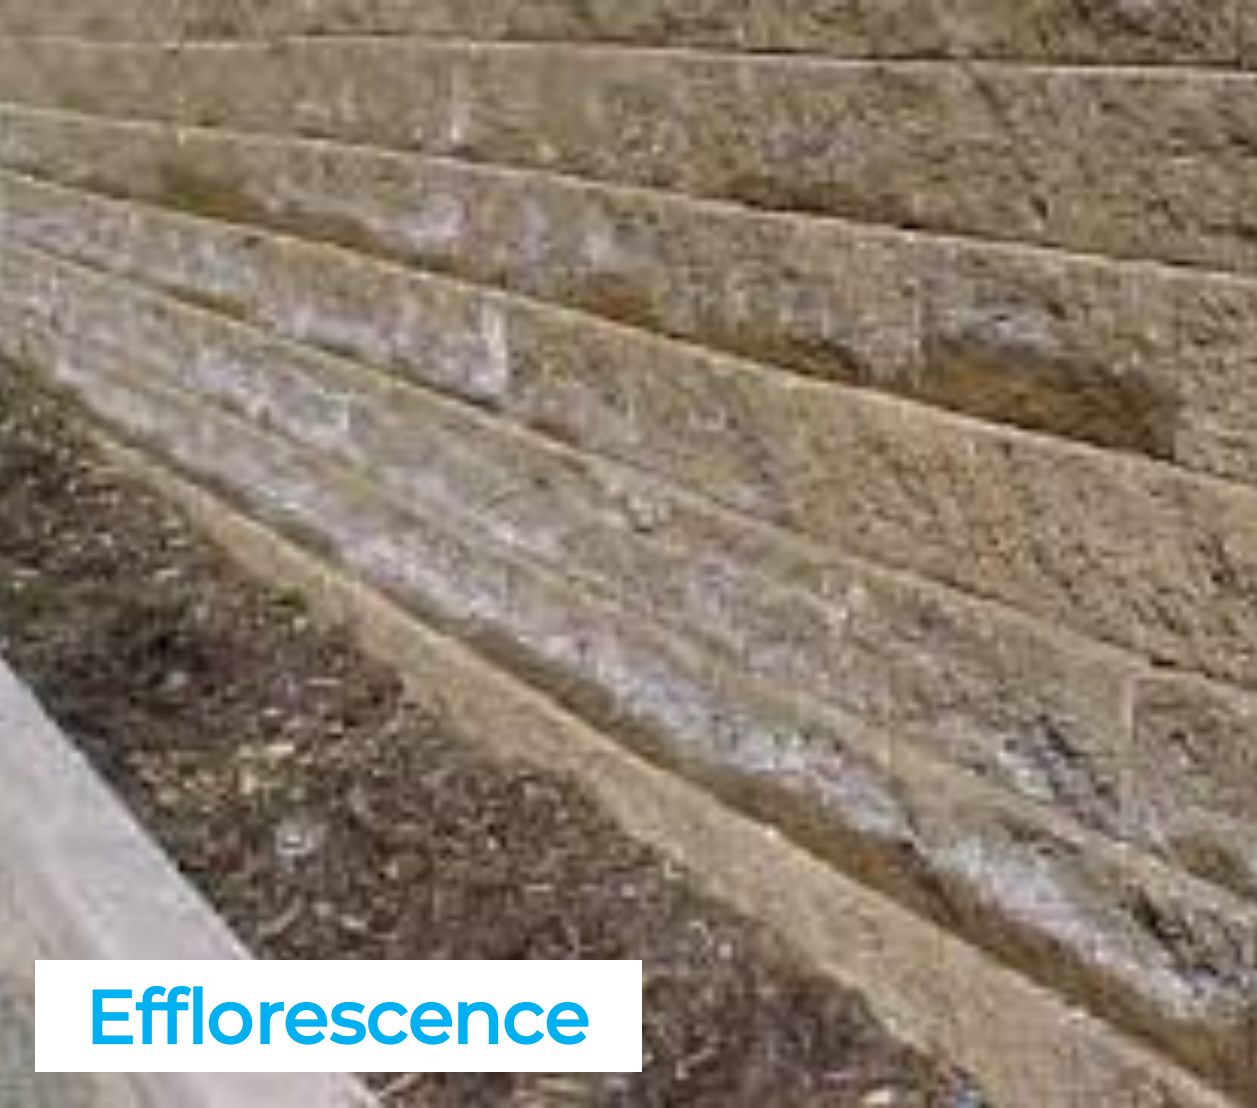
Efflorescence

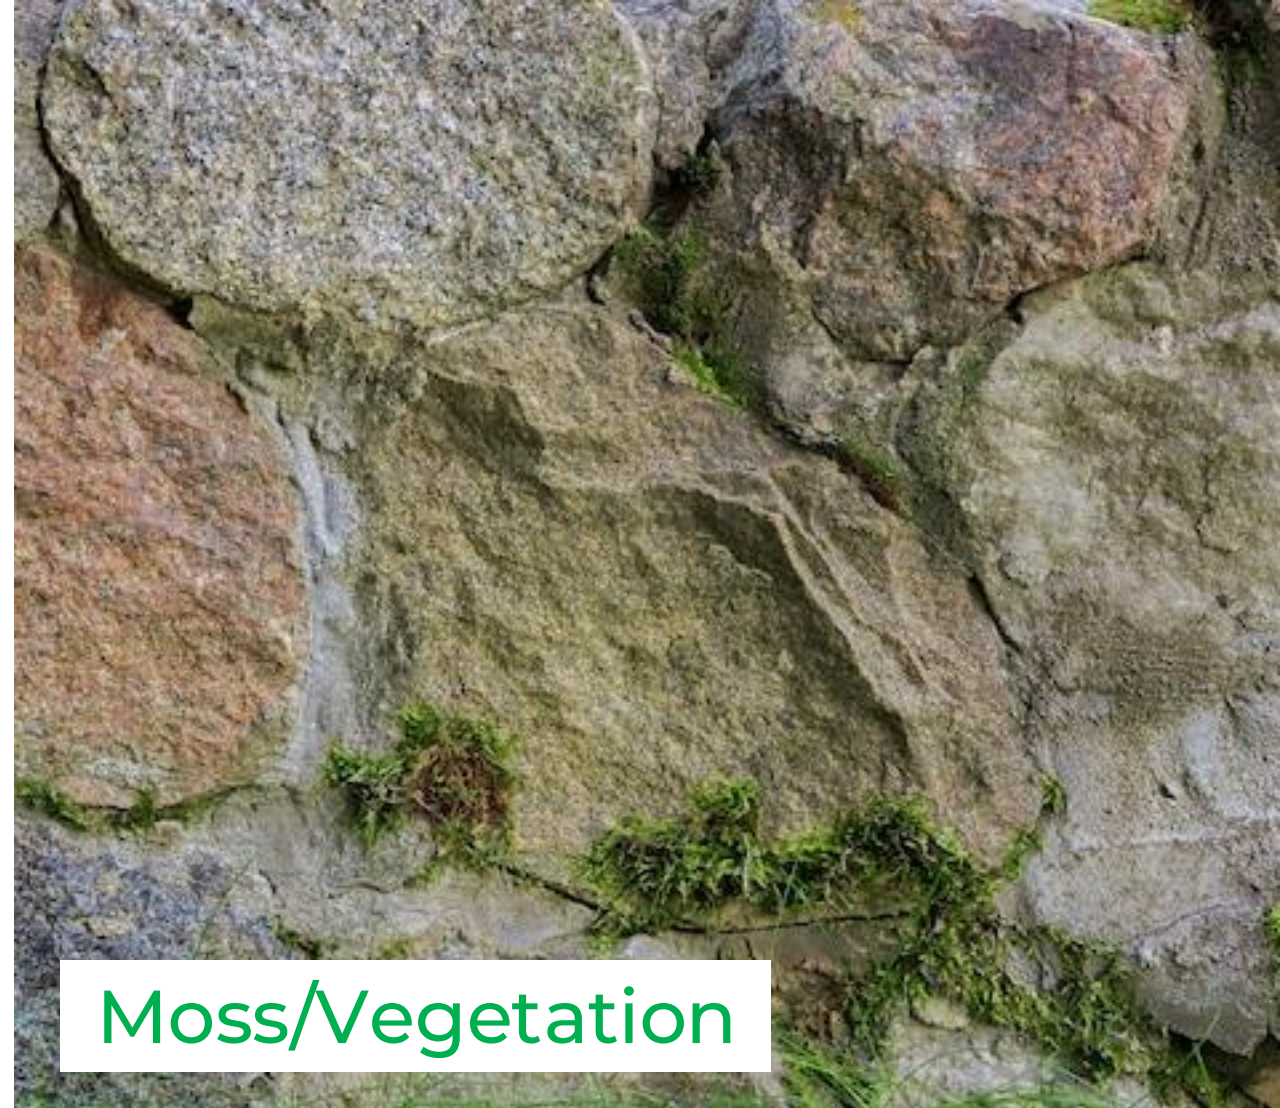
Moss/Vegetation
