# Reserve Studies 101

Presented by:

Casey Lewis, RS, PE

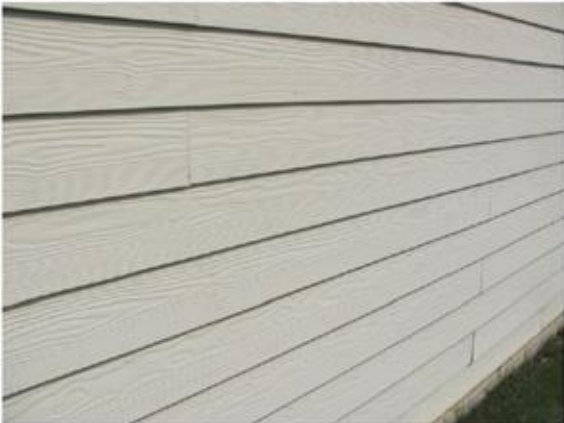
**History:** The finish at the fiber cement siding is original, and the trim and railings were painted in 2013.

**Condition:** Fair overall with locations of peeling finish, discoloration, sealant deterioration, wood rot and cracks evident

Fiber cement siding

**Priority/Criticality:** Defer only upon opinion of independent professional or engineer

**Expenditure Detail Notes:** Expenditure timing and costs are depicted in the **Reserve Expenditures** table in Section 3. We recommend the Association coordinate painting of all buildings in a single year. This will ensure aesthetic continuity, reduce total cost due to economies of scale, and minimize disruption to the unit owners. We anticipate the following during each paint application cycle:

- Paint finish application to the siding, soffits and fascia, trim and garage doors
  - Replacement of up to two percent (2%) of the siding and up to ten percent (10%) of the trim (The exact amount of material in need of replacement will depend on the actual future conditions and desired appearance. We recommend replacement wherever cracks, delamination and deterioration impair the ability of the material to prevent water infiltration.)
- Replacement of up to fifty percent (50%) of the sealants

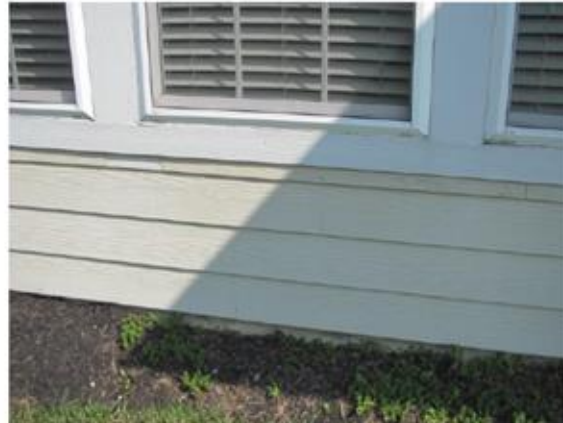
Sealant deterioration and peeling finish at fiber cement, Unit 100
